## CHAPTER 7: SUBWATERSHED RESTORATION STRATEGIES

### 7.1 Brambleton

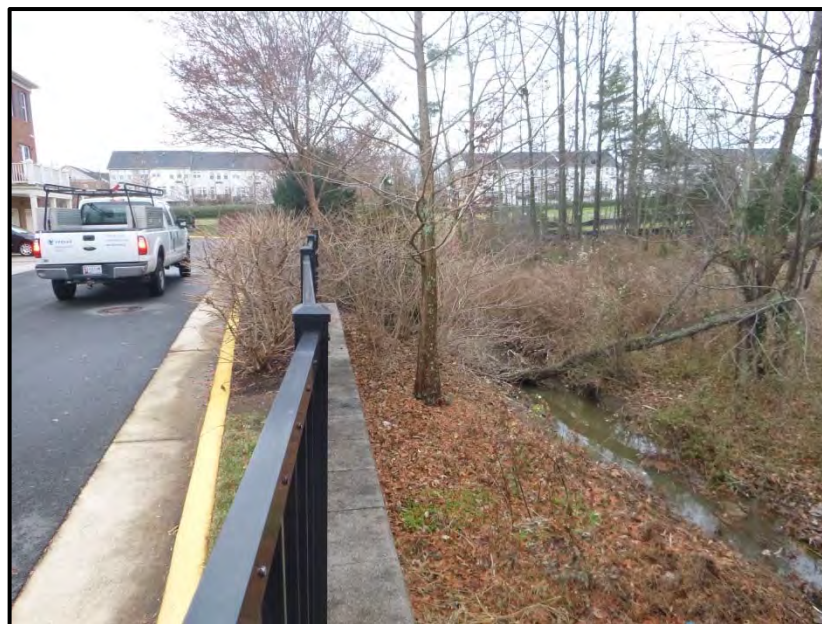
**Figure 7-45: Stream Buffer Encroachment in NSA-20**

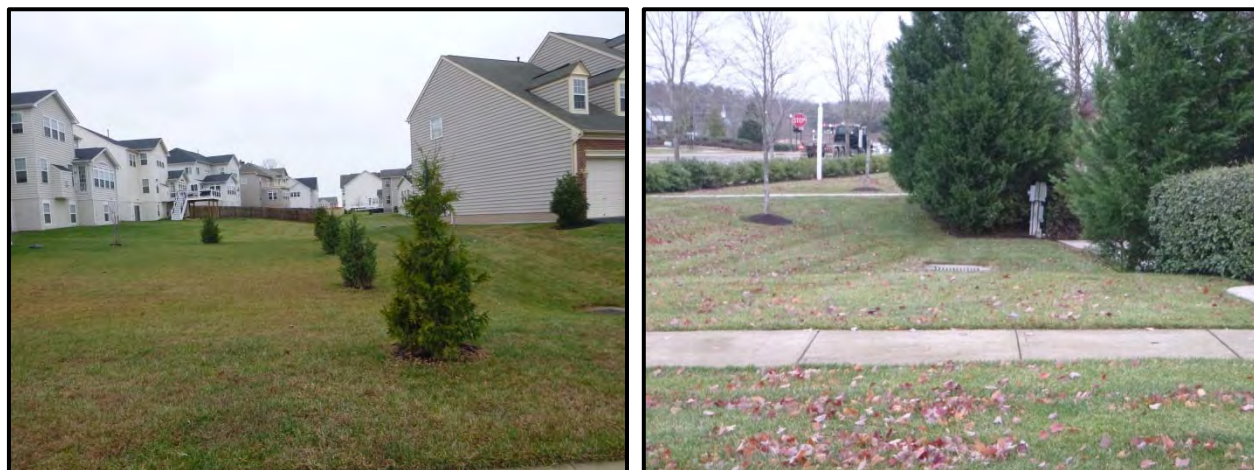
**Figure 7-46: Opportunity for Rain Garden Installation within NSA-22 (left) and NSA-18 (right)**

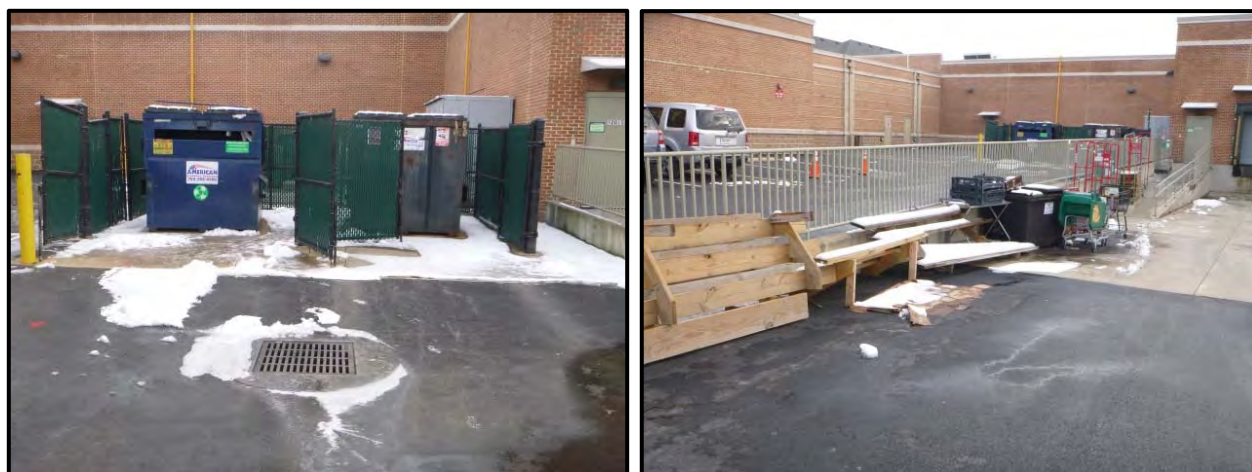
**Figure 7-47: Dumpsters Placed Near Storm Drain Inlet (left) and Bulk Trash Items Stored Outside (right) at HSI-010**

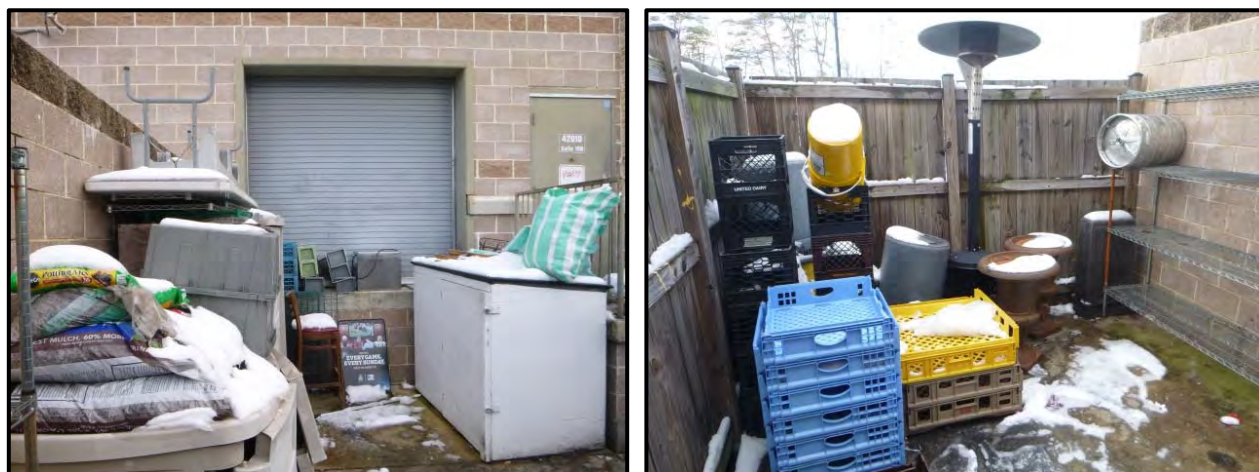
**Figure 7-48: Bulk Items Stored Behind HSI-010**

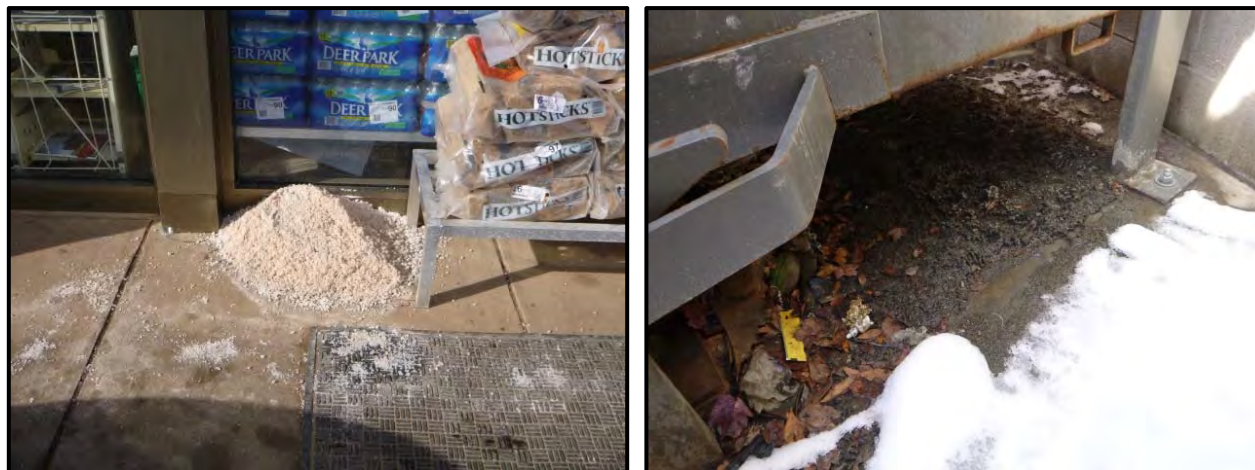
**Figure 7-49: Salt Pile (left) and Leaking Trash Compactor (right) at HSI-011**

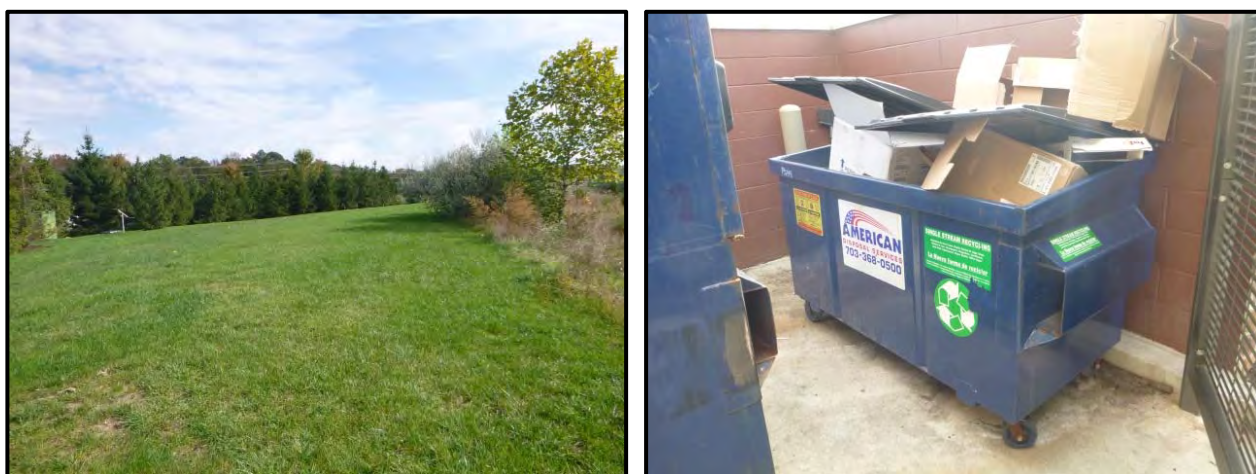
**Figure 7-50: Tree Planting (left) and Waste Management Improvement (right) Opportunities at ISI-001.**

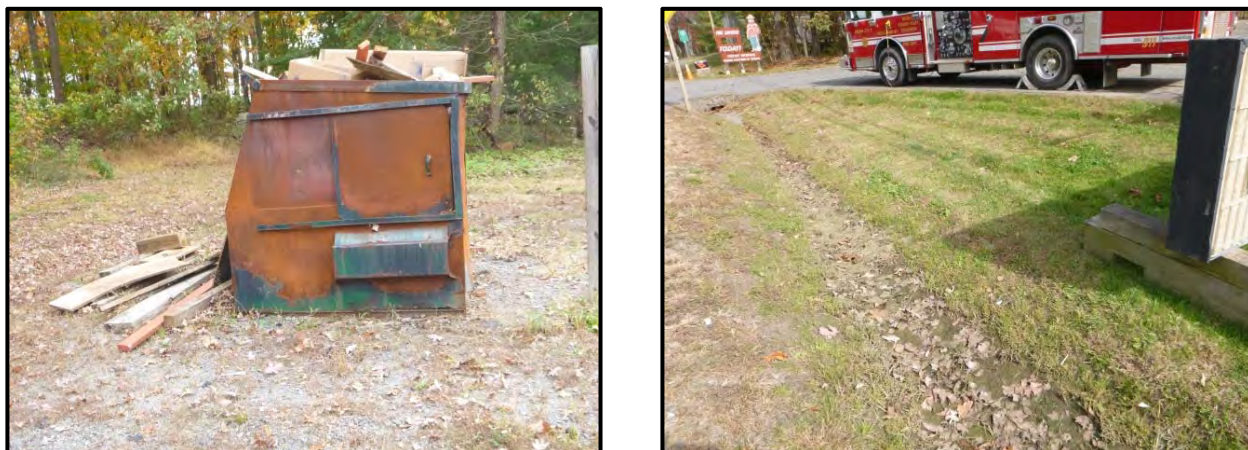
**Figure 7-51: Rusted and Overflowing Dumpster (left) and Bioretention Opportunity (right) at Arcola-Pleasant Valley Fire Station.**

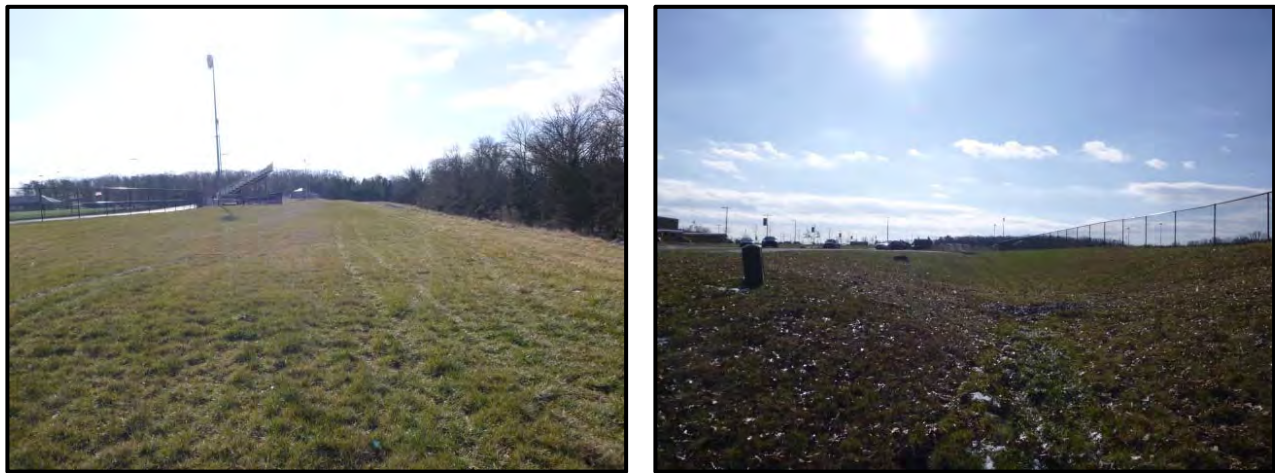
**Figure 7-52: Tree Planting (left) and Bioretention Opportunity (right) at John Champe High School.**

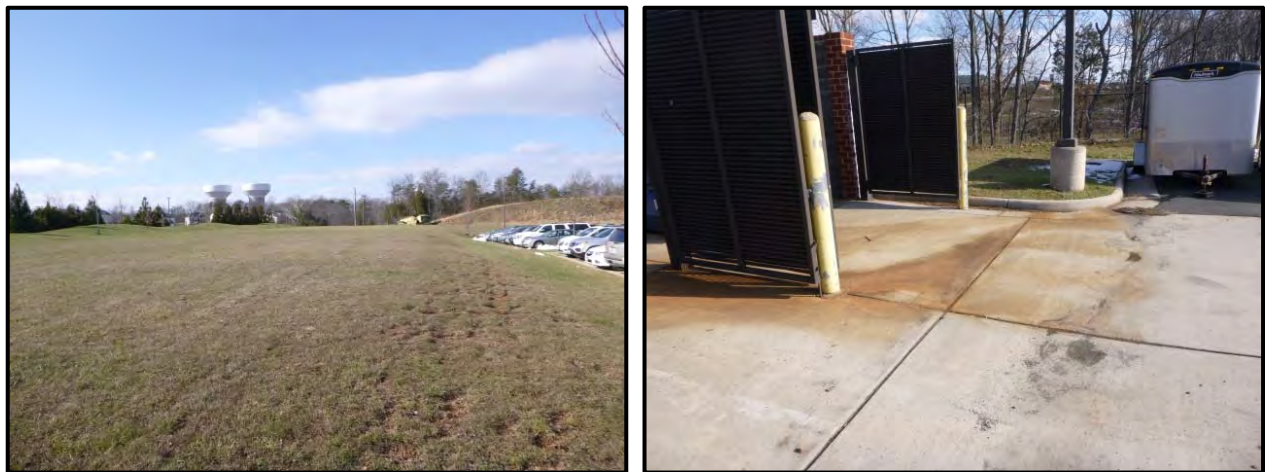
**Figure 7-53: Tree Planting Opportunity (left) and Impervious Area Staining Near Dumpster Stalls (right) at Arcola Elementary School**
